## BALLISTICS/FORCED ENTRY RESISTANCE TEST REPORT

TEST 5-AA1 TESTING OF DEFENSELITE PRO GLAZED FIXED WINDOW

N2701.01-119-12 R1

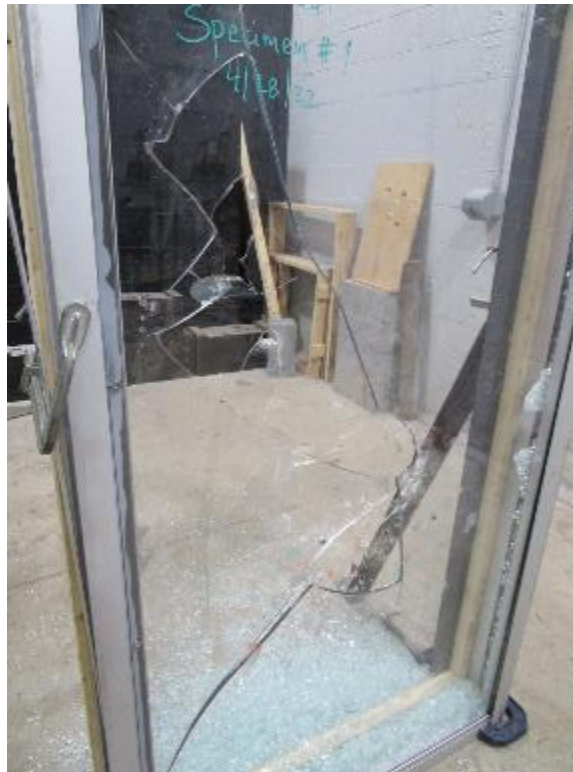
**Photo No. 5**

**Forced Entry Resistance Testing Part 2, Failure - Post-Test Exterior**

The assault team was unable to create an opening large enough to pass the 4 in diameter ball through after one minute and fifteen seconds of Concentrated Assault Testing. After two minutes of Forced Entry Resistance Testing Part 1, no opening was created for the 4 in diameter ball to pass through. After fifty seconds of Forced Entry Resistance Testing Part 2, a hole large enough for the 4 in diameter ball to pass through was created. Total elapsed test time was four minutes and five seconds.
