IMPACT SECURITY, LLC ACOUSTICAL PERFORMANCE TEST REPORT

ASTM E90 SOUND TRANSMISSION LOSS TESTING ON A DEFENSELITE PRO, FIXED WINDOW

N2700.01-113-11-R1

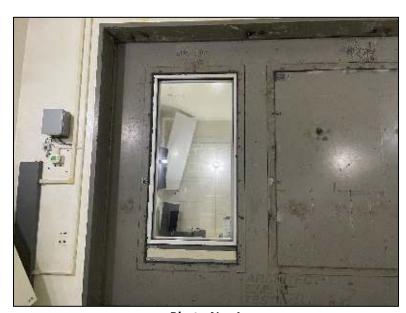
Photo No. 1
Interior View of Installed Test Specimen

The specimen plug was removed from the filler wall assembly. The specimen was placed on an isolation pad in the test opening. Duct seal was used to seal the perimeter of the specimen to the test opening on both sides. The interior side of the specimen, when installed, was approximately 1/4" from being flush with the receive room side of the filler wall. A stethoscope was used to check for any abnormal air leaks around the test specimen prior to testing. Operable portions of the test specimen, if any, were cycled at least five times prior to testing.

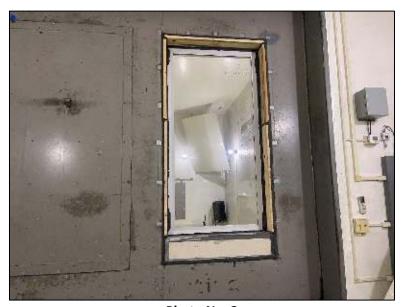
Photo No. 2 Source Room View of Installed Test Specimen
